# SLIDING WINDOW WATER DRAINAGE SYSTEM

## UNBLOCKING THE DRAINAGE CHANNEL

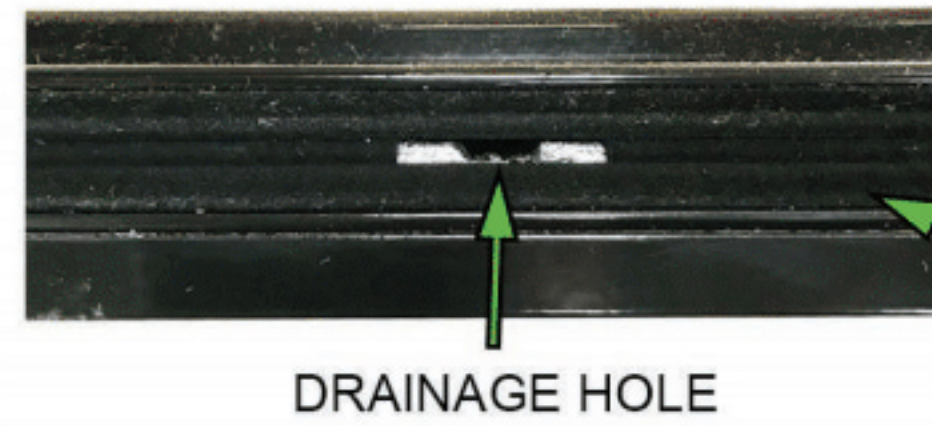
**FIG 2 - LOCATION OF DRAINAGE CHANNELS IN RAIL**

TOP VIEW OF RAIL

INSIDE OF WINDOW

Locate the drainage hole in the lower sliding rail (see FIG 2).
